# Case Study: Offset Idler Rolls Eliminate an Idler Junction Failure in Solid Woven PVC Belt

Andrew Jennings, P.E.<sup>1\*</sup>

## Abstract

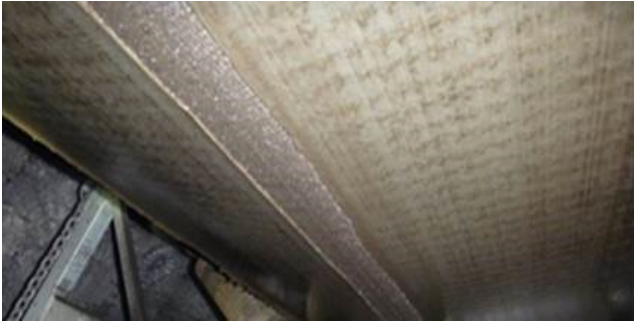
Figure 1 and Figure 2 show the failing bottom cover of the belt in the idler junction of the belt on the longwall retraction conveyor. Figure 3 shows a cross-section of this belt supported by its original inline idler assembly. When this cross section was removed, the cover of the belt was just beginning to delaminate from the carcass. The failure in the junction begins as cover delamination, not cover wear. Since the failure took thousands of cycles to appear, we concluded that the delamination is a fatigue process. All belt manufacturers with product installed on this conveyor produced reports showing that the top and bottom covers of their solid woven belts met Australian Standard AS1334.7's minimum ply to carcass adhesion requirements in the longitudinal and transverse directions. Standard ply adhesion tests measure the force required to peel the cover of the belt away from the carcass. This test generates a very high localized non-uniform strain in the cover (Figure 4). The strain levels generated in this test are much higher than the strains found in the long-wall retraction conveyor. Failure in AS1334.7 is achieved

**Figure 1.** Bottom Cover Idler Junction Failure in Longwall Retraction conveyor

CDI investigated the junction failure and recommended modifications to the conveyor to resolve the issue. Following CDI's recommendations, the operator changed the idler rolls from an inline 5-roll assembly to an offset 5-roll assembly. An inline idler set is an idler set in which all the rolls share a common centerline when viewed in plan. Inline assemblies always contain a gap between adjacent rolls. An offset idler set is a set in which the centerlines of alternating rolls are offset in plan. Typically, adjacent offset rolls overlap when viewed from the front of the set and no gap between the rolls

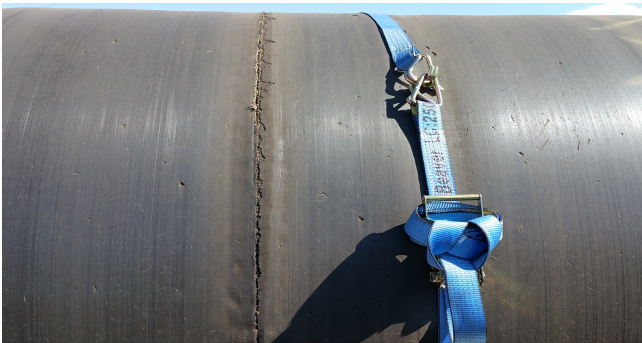
**Figure 2.** Roll of belt removed with a split in excess of 100m

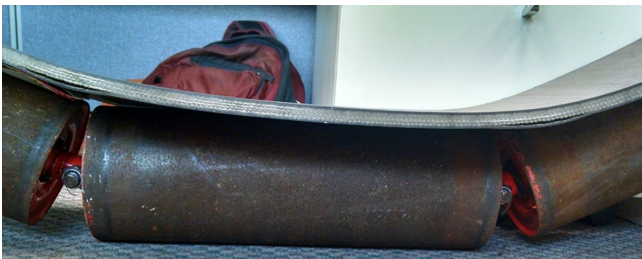
**Figure 3.** Longwall Retraction Conveyor Belt on Inline 5 Roll Assembly

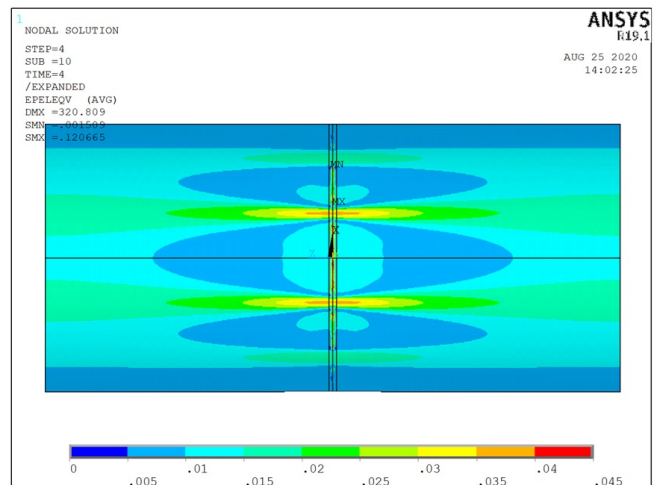
The Von-Mises strain at the interface between the bottom cover and the carcass of the original belt on the longwall retraction conveyor is shown in Figure 8. The peak strain in the junction was above 3.5%. Changing the idler rolls from

Figure 8. Von Mises Strain in the bottom cover of the original longwall retraction conveyor. Peak Strain in junction is exceed 3.5%.

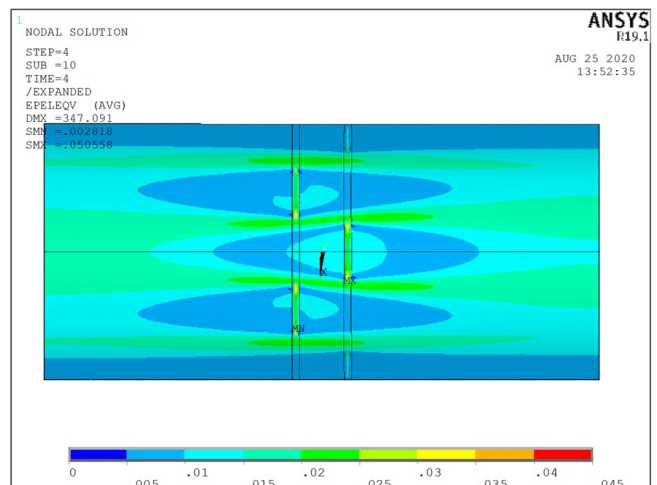
inline to offset rolls reduced the peak elastic strain to less than 2.5%, a 29% reduction and dispersed the strain more evenly through the cover (Figure 9). By 2017, all inline rolls were replaced with offset idlers and no further junction failures were observed. This study establishes the allowable strain in the idler junction in solid woven PVC belt, which can serve as an important reference for future applications.

Figure 9. : Von Mises Strain in the bottom cover of the longwall retraction conveyor with offset rolls. Peak Strain is less than 2.5%.
