MINIMIZING BELT WEAR AND DAMAGE FROM OPTIMIZED CHUTE DESIGN

Jason Aldrich, Conveyor Dynamics, Inc., Bellingham, Washington, US
Yijun Zhang, Conveyor Dynamics Inc., Bellingham, Washington, US

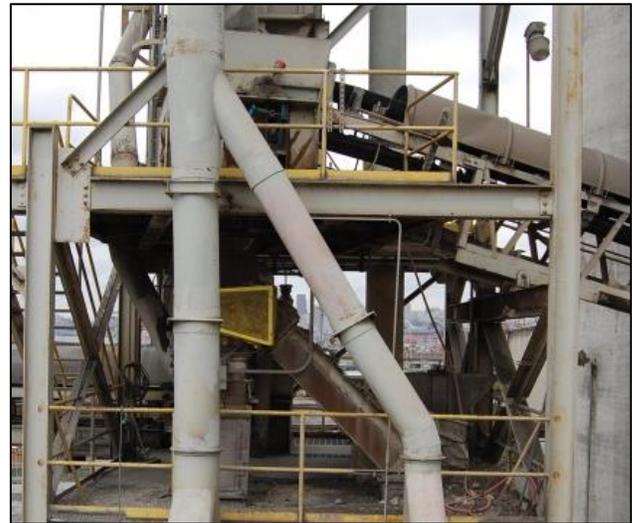
Figure 9. Ash Grove Cement Company, Seattle Plant, Original Design at TT6

The original chute configuration consisted of a single discharge conveyor, an asymmetrical gate, and two legs, one of which has a rock box at its discharge. The design throughput was 200 tph and the conveyor information used to configure the DEM simulations is shown in Table 1.

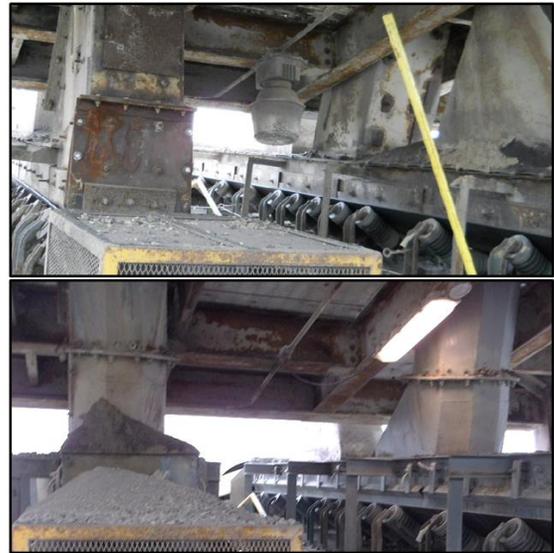
Lastly, the curved spoons are designed to slow the material before discharging onto the receiving conveyors and the chamfered corners, which match the legs, continue to center the material (see Figure 13).

Figure 13. Lower Discharge Chute Geometries; Original Above; New Below

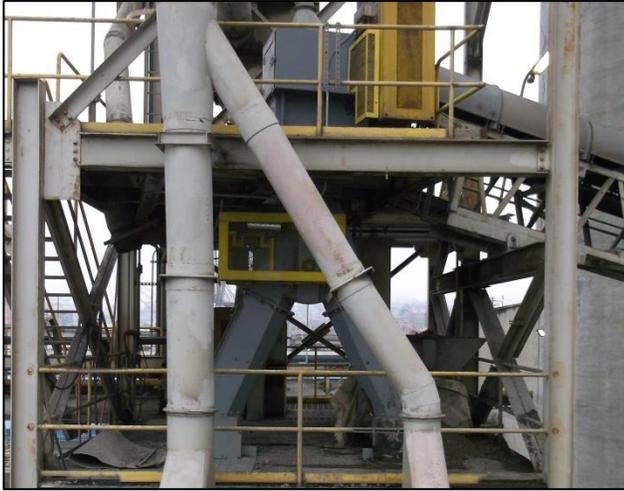
Figure 14. Ash Grove Cement Company, Seattle Plant, Proposed Design installed at TT6

After 1.5 plus years of being in operation, Ash Grove reports the chute has had no issues with plugging, and fully has met their performance requirements.
