Conveyor Belt Bottom Cover Failure from Idlers and Pulleys

Yijun Zhang, Ph.D, P.E., Conveyor Dynamics, Inc.

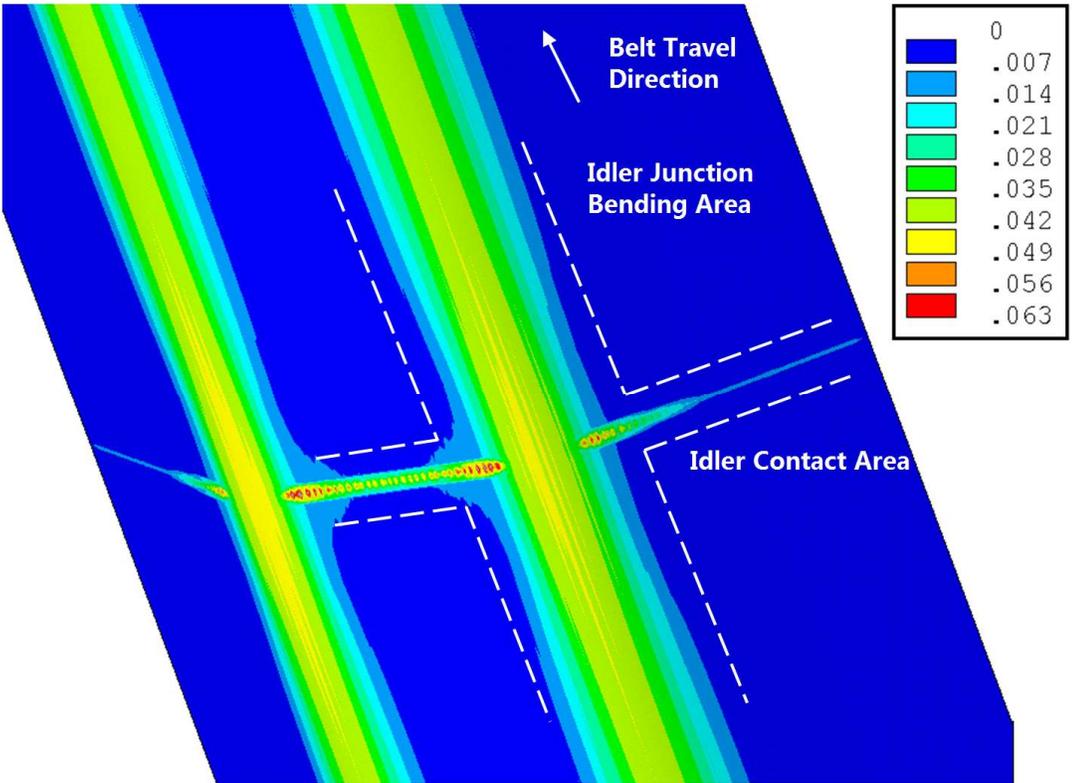
The conveyor belt bends at the junction between idler rolls. The bending creates compression in the belt's top cover and tension in the bottom cover. The extent of this deformation depends on the idler arrangement, belt properties and belt loading. Figure 1 shows a finite element analysis of the deformation in a steel cord belt on three-roll trough (idler set not shown in the figure). The idler junction bending area is along the belt travel direction, symmetric along the belt center line, and separates the belt's contact between the center roll and wing roll. Deformation in the idler junction area is mainly due to bending. Deformation in the idler contact area is mainly compression from the material and belt load, and shear from rolling resistance. The red dots in the idler contact area are high pressure points directly under individual steel cords, which relates to a different type of bottom cover failure.

Figure 1. Equivalent (von Mises) strain in the belt bottom cover of a steel cord belt from finite element modeling.

In Figure 1, the idler contact area shows high deformation areas (red dots) which are under individual steel cords. The contact pressure is relaxed under the rubber gap between adjacent steel cords. Also the contact pressure near the edge of the wing roll and center roll is higher than the rest. Combining the two effects, the localized contact stress can be significantly higher than the average contact stress over the entire contact area.

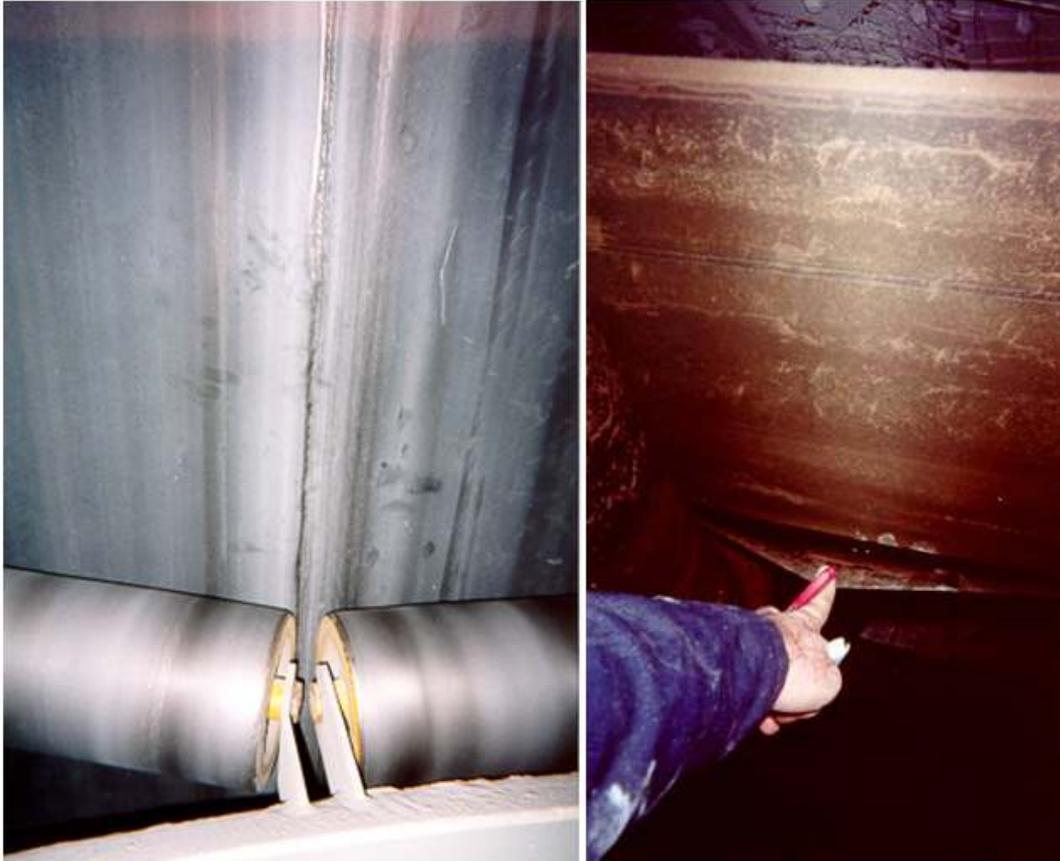
High tensile strain in the bottom cover, due to severe bending at the idler junction, can facilitate surface cracks. The surface cracks may develop from short lengths to long stretches and further coalesce to cause deep cover failure. An example of this idler junction failure is illustrated in Figure 2. Some belt manufacturer's manual mentions this type of failure without detailed analysis (2).

Figure 2. Idler Junction Cover Failure

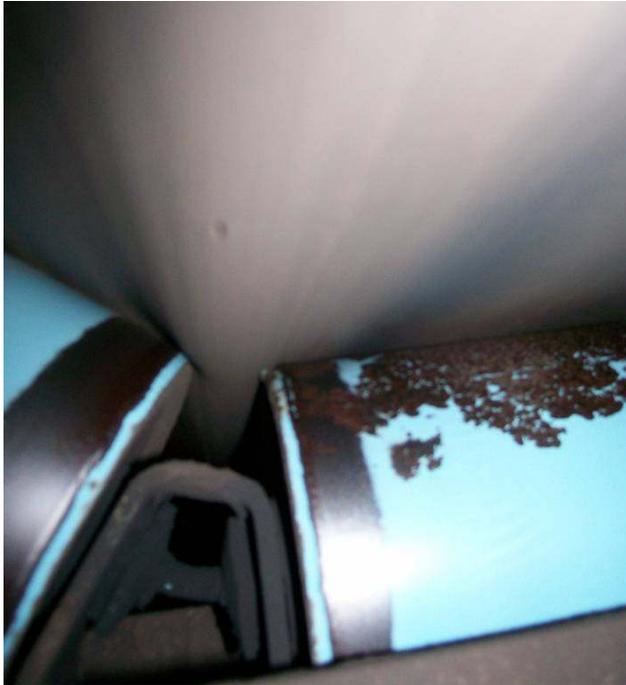
Idler Configuration: For an inline idler arrangement, where all rolls are at the same plane, there is a gap between adjacent idler rolls. If the gap is wide enough and the belt's idler junction bending is severe enough, the belt can contact the idler edge. Figure 3 shows an example of a belt contacting the idler edge. When this scenario occurs, the idler edge acts like a knife edge, where the contact stress between belt and idler edge is very high and leads to high rate of cover wear. An improved design is the offset idler arrangement, where the rolls are staggered to create an overlap at the idler junction. This eliminates any potential contact between belt and idler edge. A large diameter idler roll reduces the contact stress between belt and idler, and the idler junction bending is reduced. For the same belt width, a five-roll trough arrangement reduces the idler junction bending, compared to a deep trough three roll arrangement, because there are additional idler junctions so the bending angle at each idler junction is reduced.

Figure 3. Belt Contacting Idler Edge

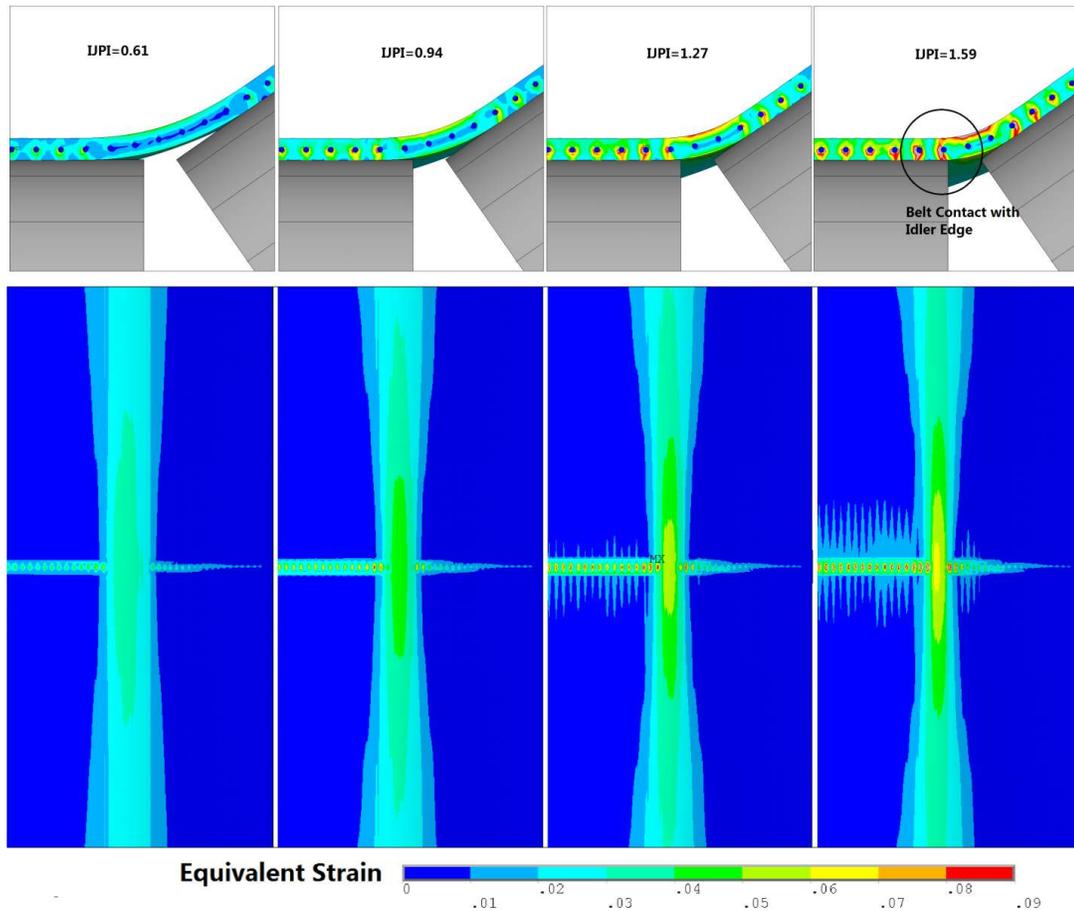
CDI developed the Idler Junction Pressure Index (IJPI) as a quantitative tool to indicate the idler junction bending stress. The IJPI allows the designer to explore various conveyor and belt parameters like idler spacing, diameter, roll lengths, belt speed, belt thickness, etc., to arrive at an optimized design while maintaining allowable idler junction bending. Higher IJPI values mean more bending deformation. As a general design criterion, the IJPI should not exceed 1.0~1.2 range. Figure 4 shows a finite element modeling of the idler junction bending in a 1200mm wide, 13.5mm thick belt on a 35° degree trough. The material loading is adjusted to achieve four different IJPI values, from low to high. It is obvious that the strain and idler junction bending increase with higher IJPI value from 0.61 to 1.59. IJPI =1 can be

viewed as a relatively conservative limit. When IJPI exceeds 1.2, the belt bending becomes severe. At IJPI=1.59, the belt starts to contact the idler edge.

Figure 4. Finite element modeling of belt deformation with Idler Junction Pressure Index (IJPI). The top four graphs show the cut plane of a belt near the idler junction area. The bottom four graphs are the corresponding view of the belt bottom cover (looking from beneath the belt bottom cover)

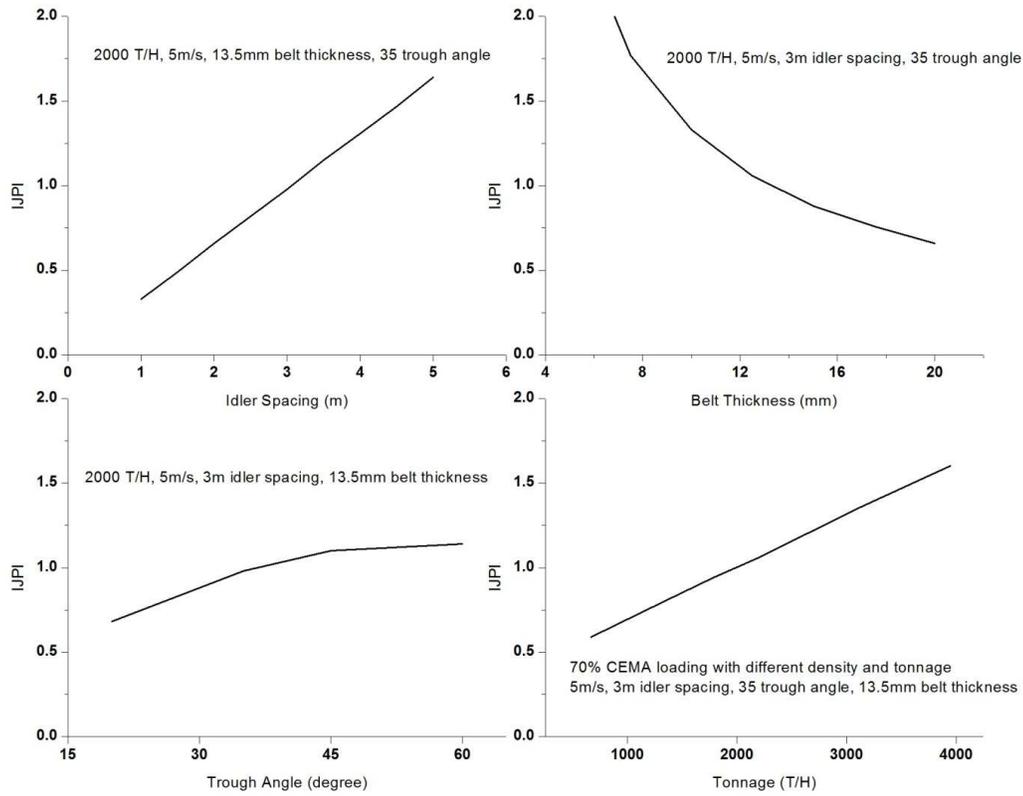
To illustrate the relationship of IJPI to conveyor and belt parameters, Figure 5 shows different IJPI on the same 1200mm wide belt, at 70% CEMA loading and 5m/s belt speed, but with varying idler spacing, belt thickness, trough angle and tonnage. Some weight related factors, like idler spacing and tonnage, show a linear relation to IJPI. Some bending related factors, like belt thickness and trough angle, show a non linear relation to IJPI. For example, the IJPI increases beyond a linear relationship with reducing belt thickness.

Figure 5. Idler Junction Pressure Index (IJPI) vs Idler Spacing, Belt Thickness, Trough Angle and Tonnage. Belt width is 1200mm for all cases.

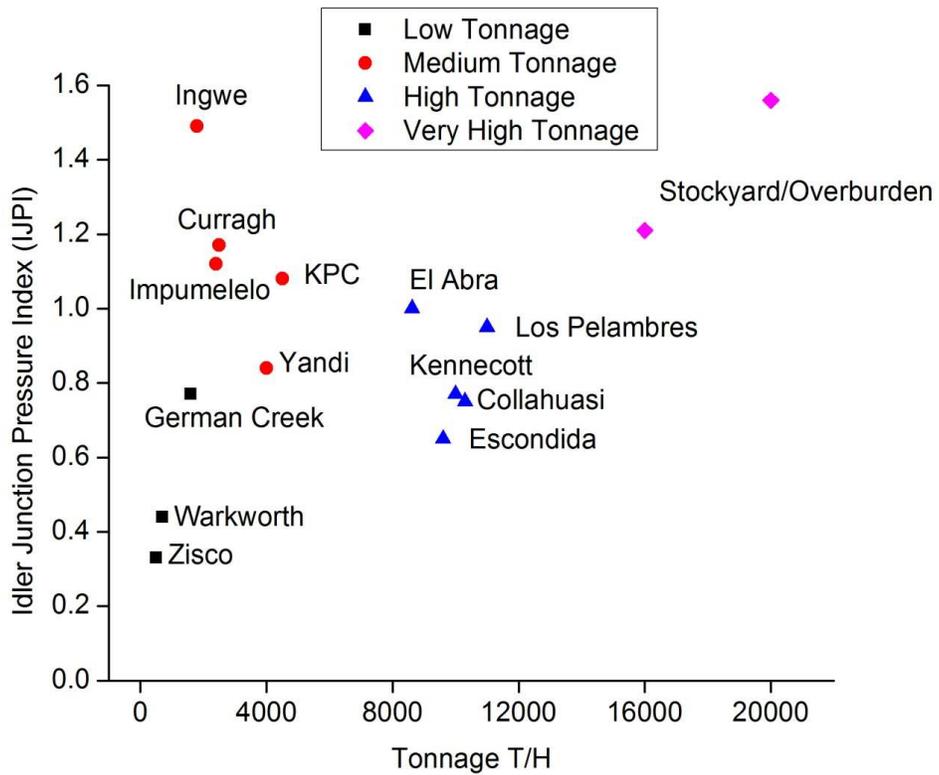
The design limit on IJPI is derived from studying belt behavior and service life on running conveyors. High IJPI should be mitigated by design changes like reducing idler spacing, increasing belt thickness or increasing belt speed. Figure 6 compiles the IJPI of selected overland conveyor projects that CDI has worked on. Major system details of these conveyors are listed in Table 1.

Figure 6. Project Examples of Idler Junction Pressure Index

Some conveyors may have undergone modifications or upgrades so the parameters may not be current. There are four categories of conveyors: first is low tonnage conveyors (<1000 T/H). Because the tonnage is low, the IJPI is low as well, even with a thin belt and extended idler spacing at 5m. The second category is medium tonnage conveyors between 1500 T/H and 4000 T/H. Conveyors in this category can have a wide range of IJPI. This is due to the wide variations in system parameters like belt rating, idler spacing, belt speed, etc. For conventional conveyor design using short idler spacing, the IJPI is expected to be low. Conveyor design can also be optimized to reduce capital and operating cost, which includes reducing belt thickness and width, increasing belt speed and idler spacing, and utilizing low rolling resistance belt to reduce power consumption. The IJPI is typically increased in an optimized conveyor design, compared to the conventional design with reduced idler spacing. It is the conveyor designer's responsibility to make sure the IJPI is within the allowable limit. The third category is high tonnage overland conveyors that are operating in some South American copper mines. Although the tonnage is high, beyond 8000 T/H, the belt thickness is also typically increased by having large diameter steel cords and thicker belt cover, because of high belt rating and hard rock handling. Short idler spacing is usually specified to limit idler load and bearing size. For these conveyors, the IJPI is normally expected to be within design limits, until the belt becomes thin from significant cover wear. The fourth category is very high tonnage conveyors beyond 15000 T/H. This type of conveyor can be found in large stockyards in bulk material handling ports or surface mining operations. These conveyors don't normally have long lengths or a high incline/decline angle, but they are characterized by wide belt and very high tonnage. The IJPI can increase very quickly with a normal three roll trough even with reduced idler spacing. Careful consideration of idler spacing and trough arrangement should be taken to limit the idler junction bending.

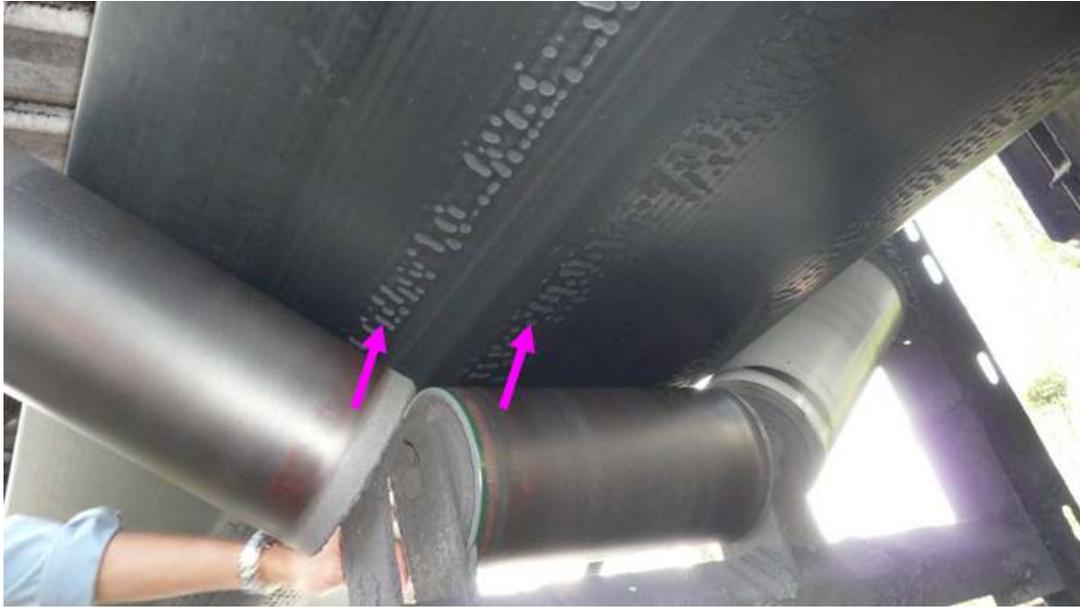
High normal and shear stress can potentially cause accelerated belt cover wear. One example is shown in Figure 7. This particular belt is traveling at a high speed with heavy material load, so both normal and shear contact stress is high. The contact stress further increases around the idler edges and directly under individual steel cords. In Figure 7, the spacing of the circular damage spots matches the spacing of steel cords in belt, which is exactly the high stress area. If the bottom cover rubber's mechanical property is not strong enough to withstand the stress or strain level, premature bottom cover belt failure will occur.

Figure 7. Bottom Cover Damage at High Contact Pressure Area

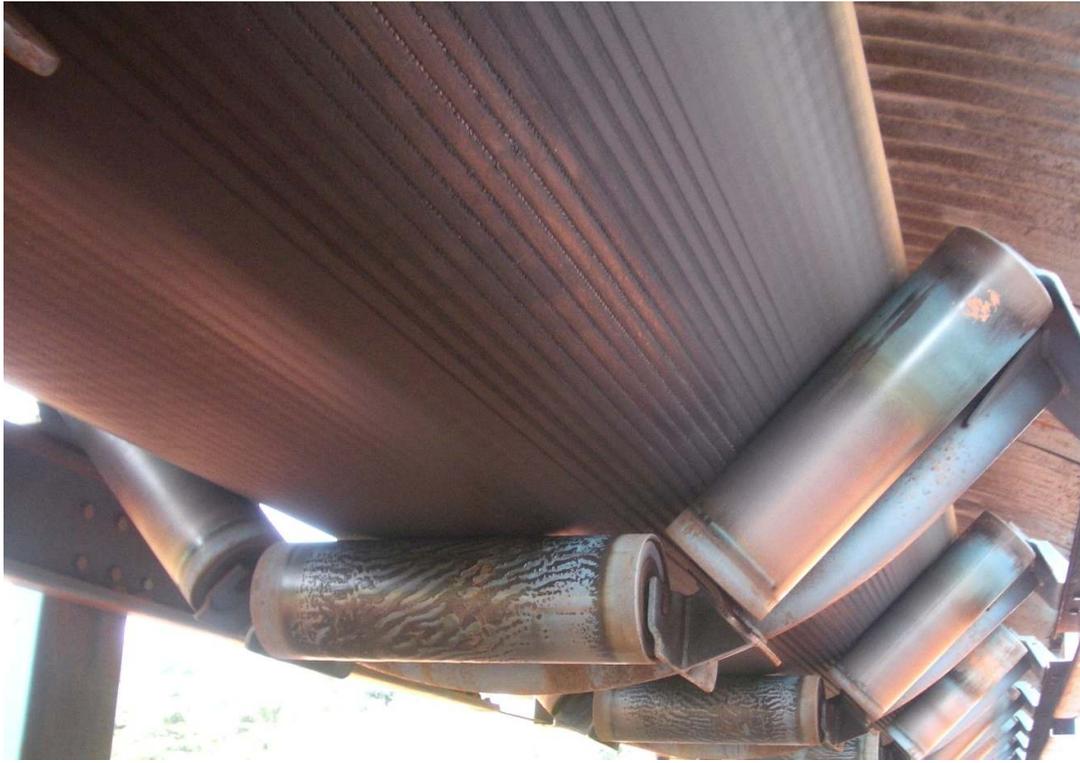
The forward tilting of an idler arrangement is adopted as a solution or precaution against belt mistracking. The rotational velocity of a tilted wing roll is at an angle (tilt angle) against the belt travel direction. The linear velocity of a wing roll can be decomposed into two components: one parallel to the belt travel, and the other normal to the belt travel. The velocity component parallel to the belt travel is a rolling contact, which has very minimal wear on the belt. The velocity component, normal to the belt travel direction, is a sliding contact. The sliding frictional force pushes the belt down and stabilizes it. But the sliding friction also creates additional wear on the belt bottom cover in the wing roll contact area. By the same argument, backward tilting is not used because the direction of the frictional force is pulling the belt upward from both wing rolls, which leads to more belt mistracking. Figure 8 shows the belt cover wear caused by the forward tilting of the wing roll. The forward tilting of wing rolls can wear the belt bottom cover down to the steel cords. The high wear area also corresponds to the high contact stress area on the wing roll near the idler junction. For short plant conveyors, belt cycle time is short and the belt top cover tends to wear very quickly. If belt mistracking creates frequent unplanned shutdown of a conveyor, it is reasonable to use the forward tilting of idler wing rolls to improve belt tracking. However such practice should be avoided for overland conveyors, when belt

Figure 8. Belt Cover Wear Due to Idler Forward Tilt

mistracking should be prevented by proper idler arrangement and good installation accuracy.

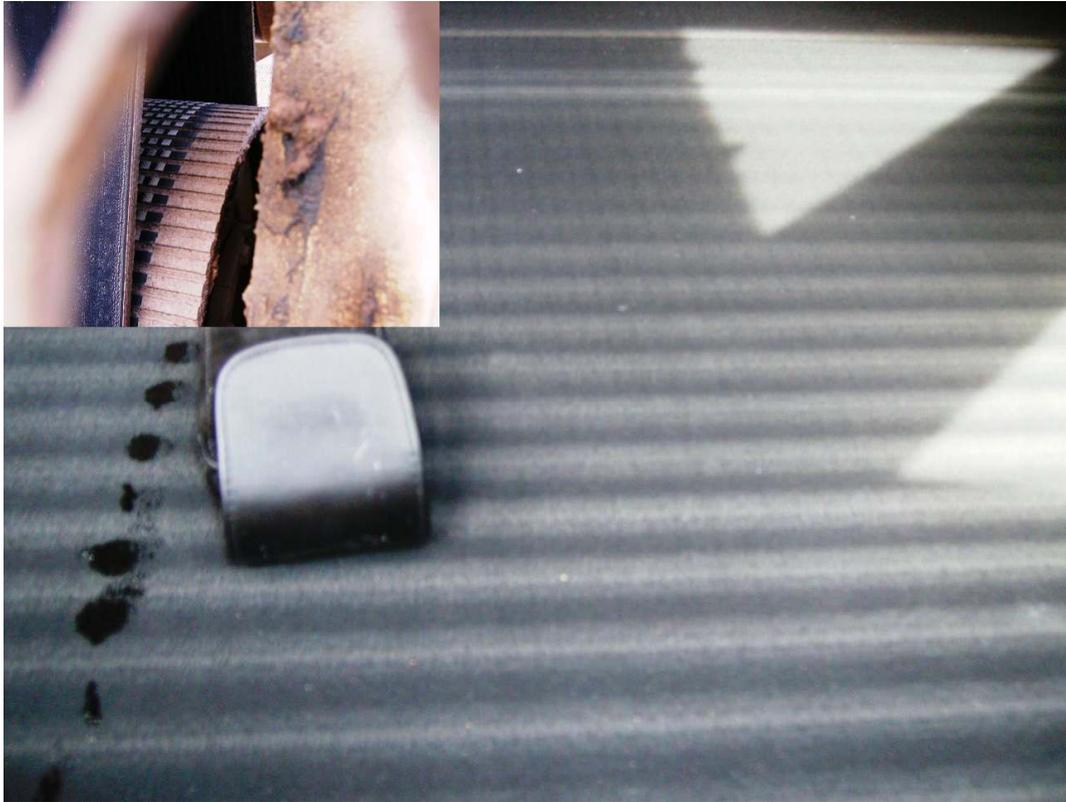
Ceramic pulley laggings are chosen for their superior wear resistance and higher friction coefficient over rubber pulley laggings. Manufacturers provide different types of ceramic lagging tile designs. Certain ceramic lagging is designed to provide a greater friction coefficient between the belt and pulley, usually by introducing small, sharp edged protrusions on the lagging surface. The protrusions are intended to penetrate into the belt bottom cover and provide greater resistance against the slipping motion of the belt. However, from analysis of classical contact mechanics (5), it is known that on a drive pulley, certain slipping is intrinsic to the interaction between belt and pulley. Aggressive ceramic lagging design, in combination with high tension ratio on a drive pulley, can potentially cause premature belt cover failure. Figure 9 shows the wear marks on the belt bottom cover produced from ceramic lagging tiles, where the spacing of the white stripes (wear marks) match exactly the spacing of the ceramic lagging tiles. Ceramic lagging tile design affects the

Figure 9. Belt Cover Wear From Sharp Ceramic Lagging Tile. The lagged pulley surface is shown in the upper left corner.

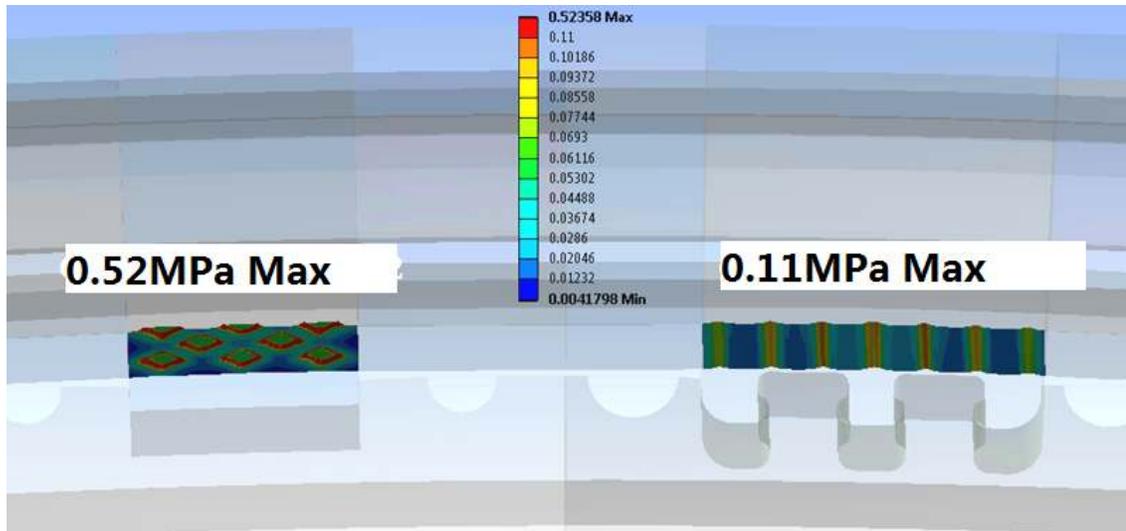
contact stress. Figure 10 shows two different ceramic lagging tiles: the left lagging tile has sharp protrusions and the right lagging tile has a wavy surface. Under the same contact condition (belt tension and pulley diameter), the contact stress is more than four times higher on the lagging tiles with sharp protrusions. Indeed the higher contact stress can provide more 'grip' between the belt and pulley, but it can also add to the possibility of belt cover damage.

Figure 10. Comparison of Contact Stress between Two Ceramic Lagging Tile Designs

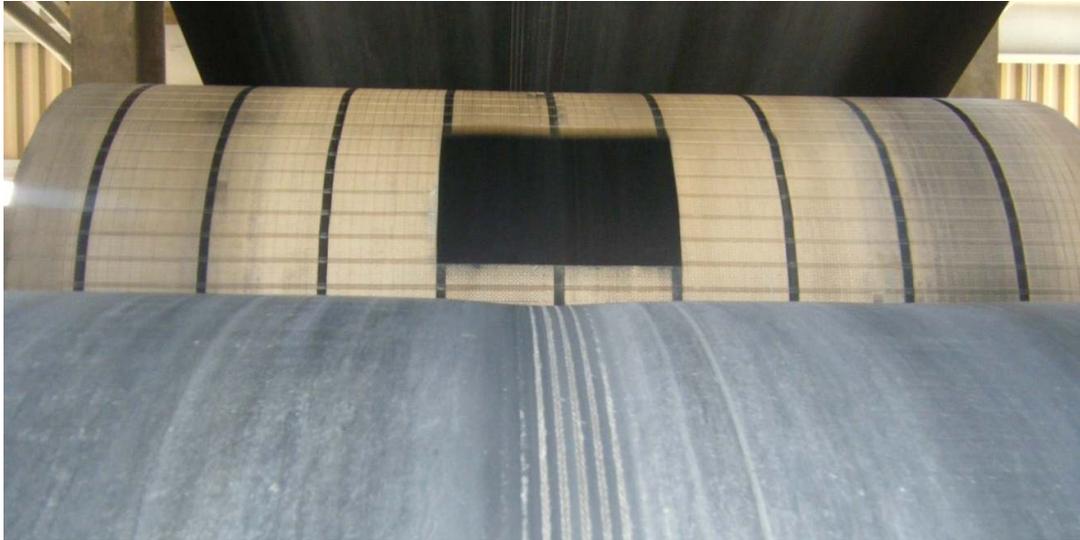
Ceramic lagging tiles may dislodge from the pulley. Missing laggings create an irregular pulley surface. Sharp corners and edges of existing lagging tiles that are adjacent to the missing pieces, are exposed to contact the belt cover and lead to accelerated wear. Figure 11 shows such an example: the belt cover has a wear zone near the center of the belt down to the steel cords, the location of which matches that of the missing lagging tiles on the pulley surface. Although a few missing lagging tiles may seem inconsequential, the related belt damage may quickly escalate to a serious level in which the whole belt needs to be replaced. Good inspection and maintenance practices are essential in preventing such belt damage.

Figure 11. Bottom Cover Wear From Ceramic Lagging

Ceramic lagging tiles with sharp protrusions can cause local high contact stress and increase bottom cover wear. Good maintenance is required to discover and fix missing ceramic lagging tiles on the pulley surface to prevent belt cover damage.
