# Case Study: Offset Idler Rolls Eliminate an Idler Junction Failure in Solid Woven PVC Belt

Andrew Jennings, P.E.<sup>1\*</sup>

## Abstract

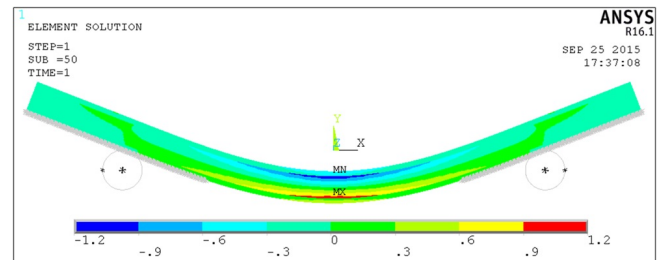
**Figure 5.** FEA Simulation of 3-pt bend test

In the warp direction, we assumed the elastic modulus of the carcass matched the ISO-9856 tested “Elastic Modulus” value reported in the belt datasheet. In the weft direction we obtained the modulus by adjusting the modulus of FEA elements until a simulation of a 3-pt bending matched (Figure

5) the actual test results on a 3-pt bending machine (not shown). Using this method, we determined that the FEA will predict the bending strain in this belt correctly when the modulus in the weft direction is 250 MPa and the modulus in the warp direction is 1874 MPa.

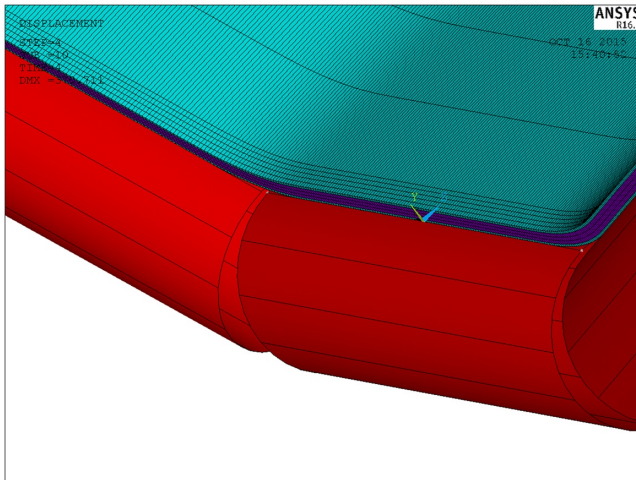
Figure 6. Initial Mesh

CDI modelled the Longwall Retraction Conveyor’s belt trough with a 45100 element ANSYS FEA model arranged as shown in Figure 6. Symmetric boundary conditions were defined on the centerline of the idler set and halfway between two idlers sets. The model assumes an orthotropic carcass material surrounded by isotropic covers. Initially, the belt is flat. Strain in the belt develops as the idler rolls rotate into position and then material load is applied (Figure 7). CDI used this model to explore the impact of various modifications to the idler trough.
